Guilford Dam Removal at Broad Brook, Guilford, Vermont

Services / Expertise

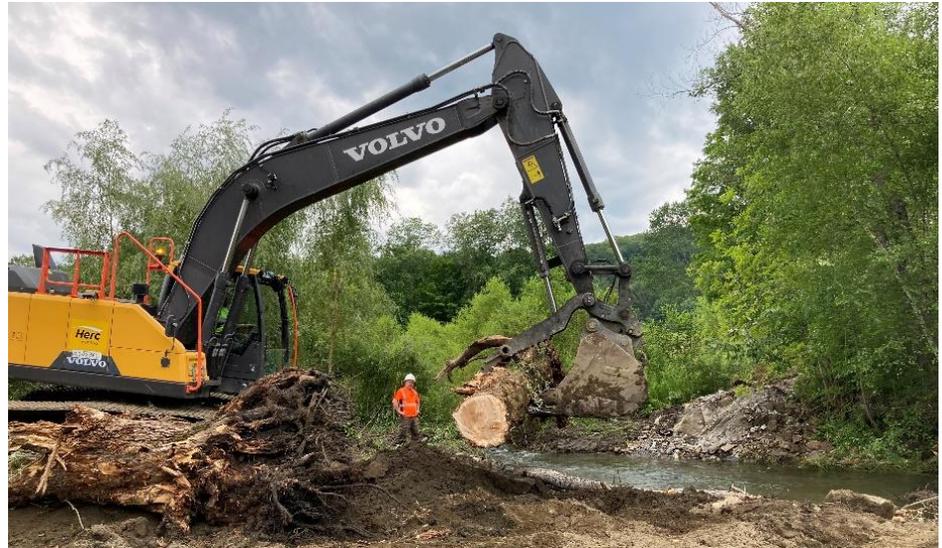
Channel construction following dam removal on Broad Brook in Guilford, VT.

Stone developed 100% design plans that included the removal of the dam and limited regrading of the channel, with the intention of letting the channel develop via natural channel processes post-dam removal. Willow rootwads sourced from trees removed within berm limits were installed along both banks just downstream of the dam to stabilize the banks over the long term and enhance habitat for aquatic organisms. The entire berm on river right was removed to reconnect the stream and floodplain and berm material will be hauled offsite. Construction access was along timber mats to limit impacts to wetlands located within the project vicinity. Project work included a stability assessment of a residential bridge approximately 400 feet downstream of the dam. Stone processed and submitted applications for a VTDEC Stream Alteration Permit, Town Flood Hazard Permit and a US Army Corps of Engineers Vermont General Permit. Stone provided construction oversight for the removal of the dam completed in August 2021.
