Mount Sunapee Resort Stream Restoration and Streambank Stabilization

Newbury, New Hampshire

17-135

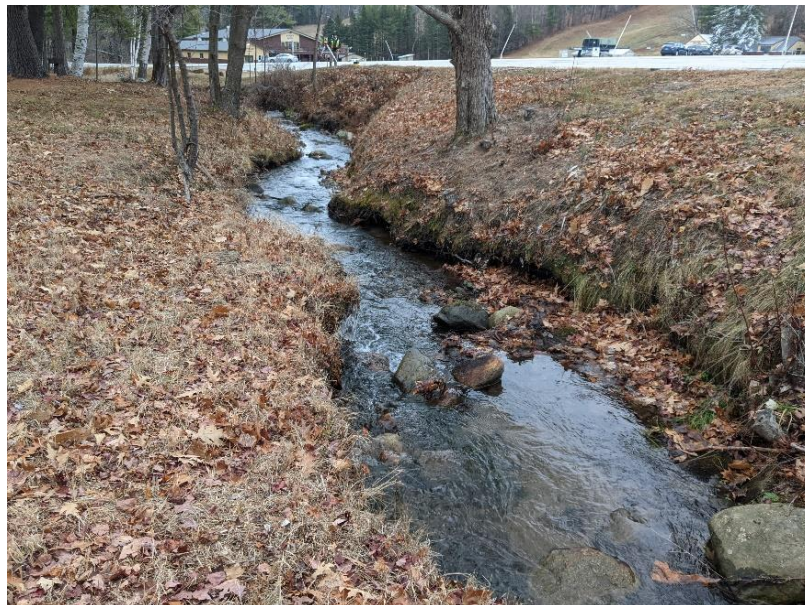
Beck Brook eroding the parking lot embankment at Mount Sunapee Resort in Newbury, NH

STONE was hired by the Lake Sunapee Protective Association to provide assessment, design, permitting, and construction oversight services for streambank stabilization along the parking lot at the Mount Sunapee Resort. The Resort was established in 1909 with a single chair lift, three trails, and a single lodge. Throughout the 1950s and 1960s the lift and trail network was expanded significantly, and two more lodges were constructed; the original lodge was replaced in 1999. Aerial imagery shows the Resort parking lot in its existing configuration as early as 1985, suggesting that it was constructed during Resort expansion in the 1950s-60s. An existing stream channel was routed around the parking lot embankment and includes a sharp 90-degree turn and approximately 500 linear feet of straightened channel. The modern hydrologic/hydraulic regime associated with incremental development and increased snow production at the Resort, coupled with increases in high intensity/high volume storm events, resulted in increasingly erosive conditions in the channel and slope failure along the toe of the parking lot embankment. Stone was retained to utilize stream restoration and floodplain reconnection techniques to repair the failures, prevent further erosion, and create a dynamically-stable stream planform with improved aquatic habitat.

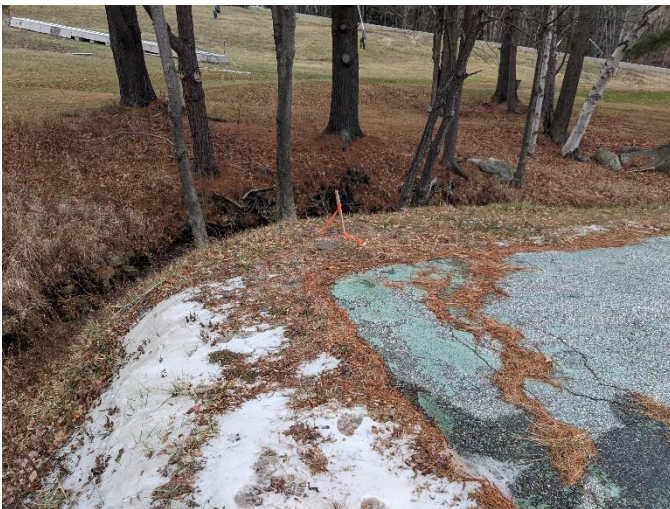
Entrenched 90-degree bend around parking lot embankment at Mount Sunapee Resort in Newbury, NH

Stone developed a restoration design that included adjusting of the stream channel away from the parking lot embankment, re-establishing channel sinuosity, grading floodplain benches along both sides of the stream channel, developing a log/boulder step-pool series for habitat and grade control, and strategic placement of stone along the bank toe in high-velocity areas. The design calls for replacing the existing culvert with a single-span bridge, re-established an open-channel configuration and eliminating flow contraction issues.

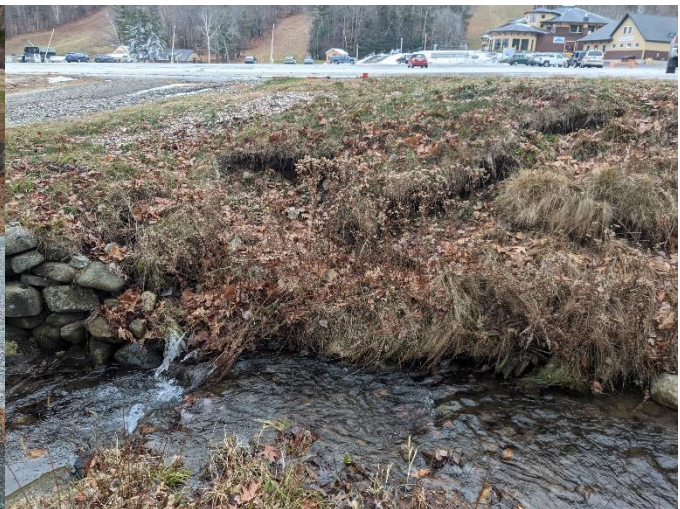
Erosion of parking lot embankment due to culvert flow contraction at Mount Sunapee Resort in Newbury, NH

Stone staff completed a full topographic survey, assessed a culvert providing passage under a vehicular/pedestrian crossing, and assessed geomorphic stability of the stream channel and adjacent banks. We found that the culvert was undersized relative to bankfull flow conditions, and as intended by the original designers, the channelized stream was generally disconnected from its floodplain. Stone compiled hydrologic data for similar gaged streams near the project site and performed a gage transfer to
