# Pine Mill Dam Removal and River Channel Restoration in Haverhill, New Hampshire

18-004

Connecticut River Conservancy

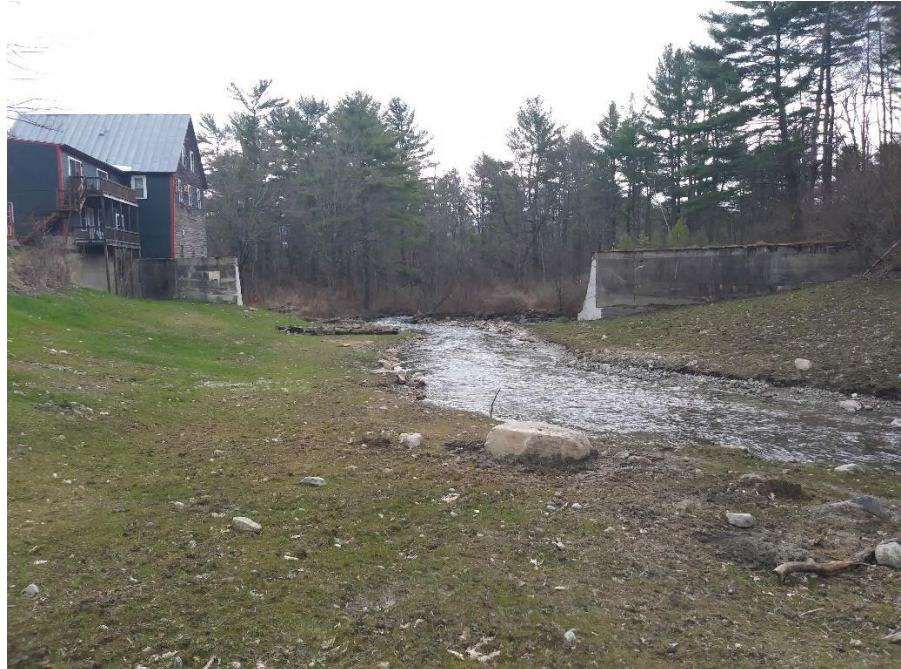
*View of the project area, following the partial removal of the dam. The low-lying areas were seeded over with grass while the upland areas were planted with trees and shrubs.*

Stone incorporated into the final design a channel restoration plan to increase channel stability, reduce flow, and improve fish habitat. This included steps, pools, riffles and large woody debris at dimensions and frequencies like those found in reference reaches. The channel design also included bank and floodplain areas that were reconnected, seeded and planted with native vegetation, and reinforced with geotextile fabrics, providing erosion protection to ensure long-term establishment of vegetation. The dam was successfully removed in September 2019 and native trees and shrubs were planted along the floodplain benches and in the uplands. Due to the historic character of the dam, the New Hampshire Division of Historical Resources will place a marker at the site, describing the dam's past use, removal, and ecological benefits to the area.
