# EFFECTIVENESS OF PHYSICAL BARRIERS AS A COMPONENT OF REMEDIAL SYSTEMS AT 4 SITES IN NEW HAMPSHIRE

2010 DCHWS Conference  
USEPA-USACE Design & Construction Issues at Hazardous Waste Sites

# 4 NH SITES EVALUATED

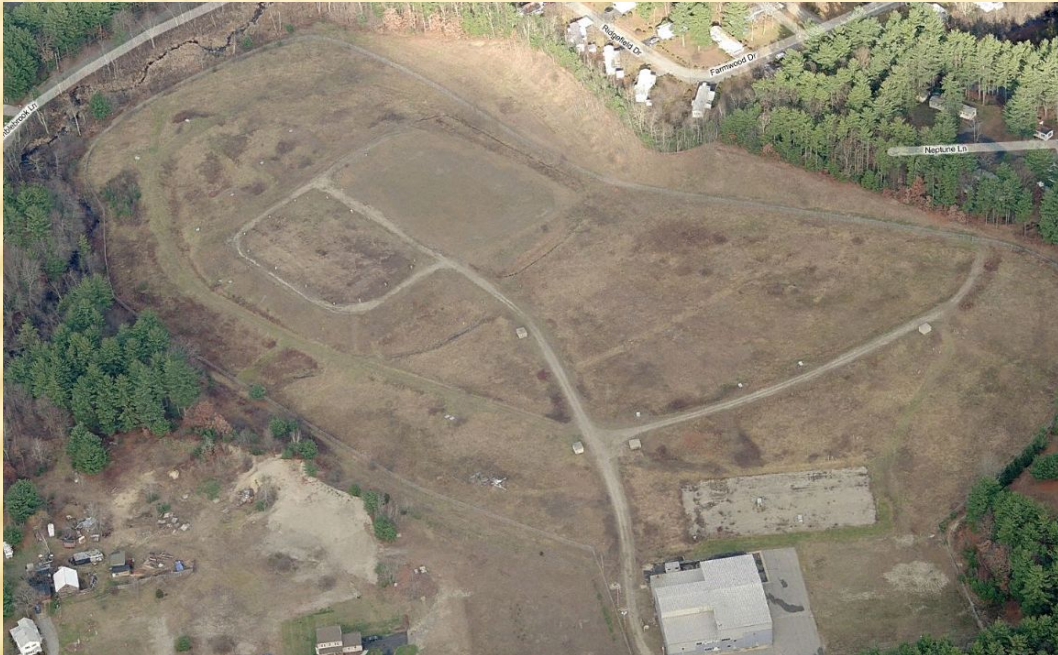
# SITE 1

- ✘ Bentonite slurry wall
- ✘ 3-4 ft wide
- ✘ 4,000 ft long
- ✘ 90 - 100 ft deep
- ✘ 20-acre area
- ✘ 40 mil HDPE cap

- GW extraction from 14 wells
- Wall & cap installed 1982, P&T started 1986
- SVE from 66 wells started in 1993
- Pump & Treat, SVE ended 1996

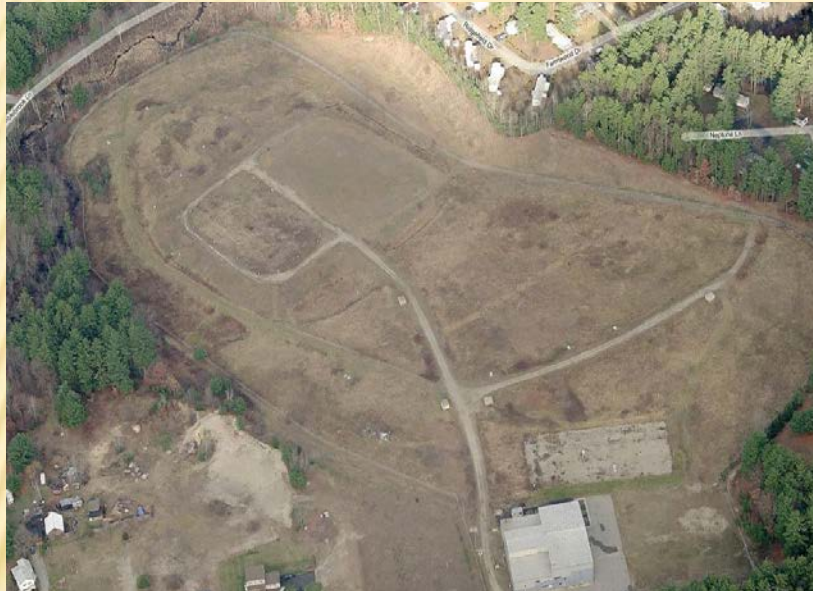
# SITE 1 REMEDIAL SYSTEM

- 30,000 to 50,000 gpd leakage through fractured bedrock
- 300 gpm extracted
- 250 gpm reinjected inside wall
- 50 gpm discharged outside wall

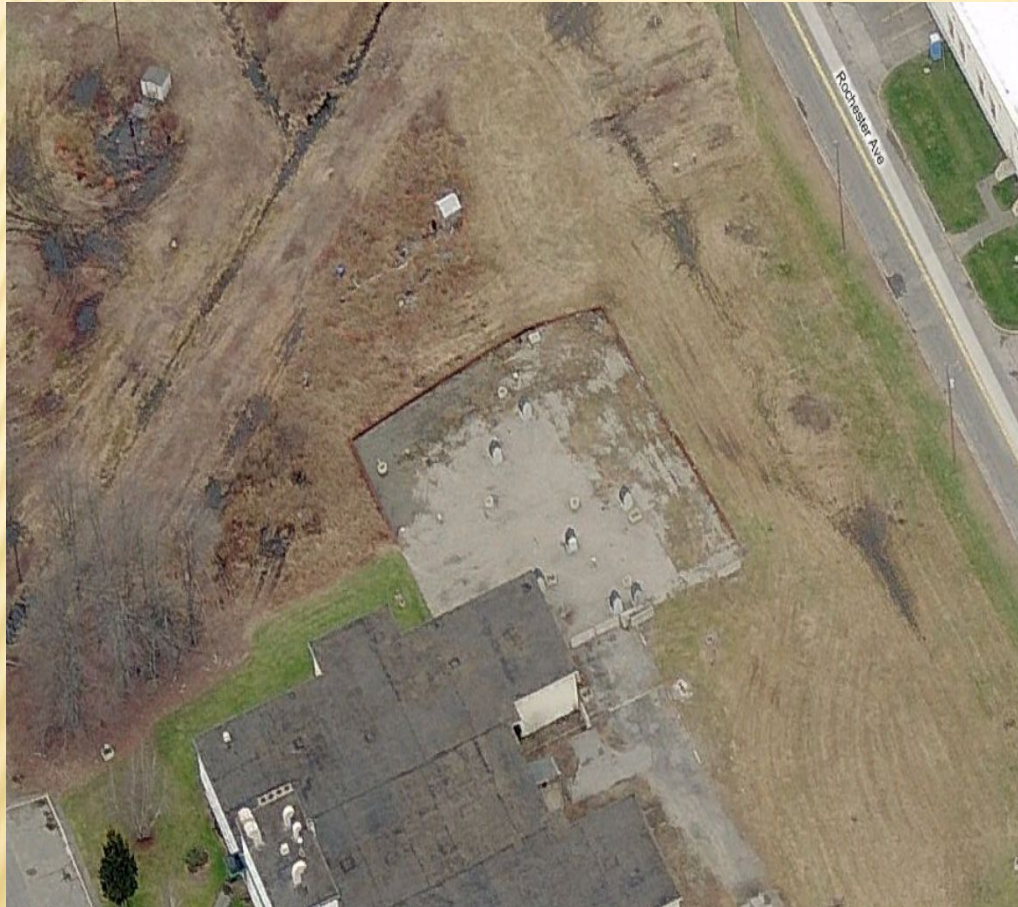
# SITE 2

- ✘ Former location of TCE UST with overflow pipe
- ✘ Technical Impracticability Site
- ✘ Sheet pile wall, no cap, encloses 1/3 acre

- Wall installed Nov 1996, P & T began Feb 1997

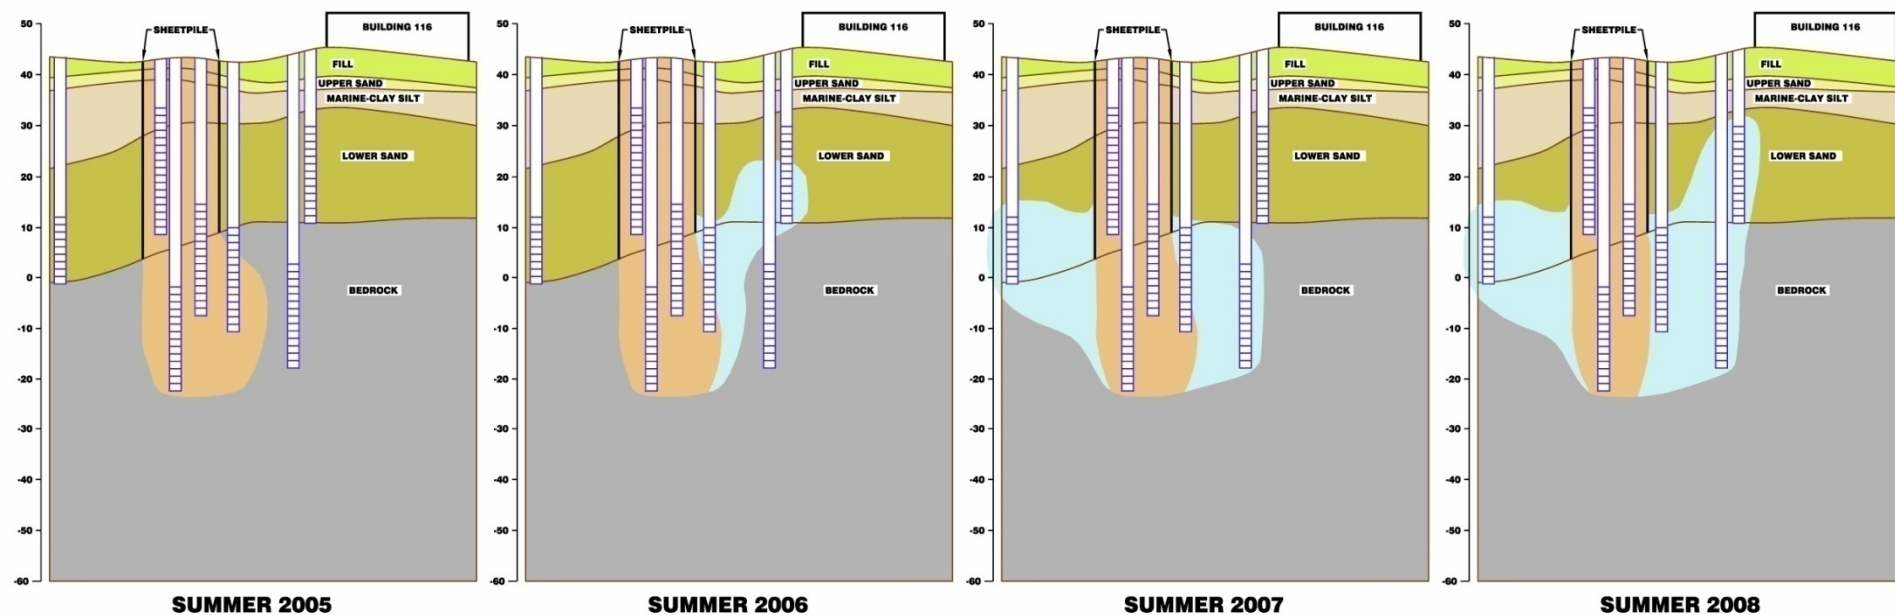
# SITE 2 - CROSS-SECTIONS

- Decreased capacity from extraction wells
- Bedrock plume of cis-1,2-DCE is expanding

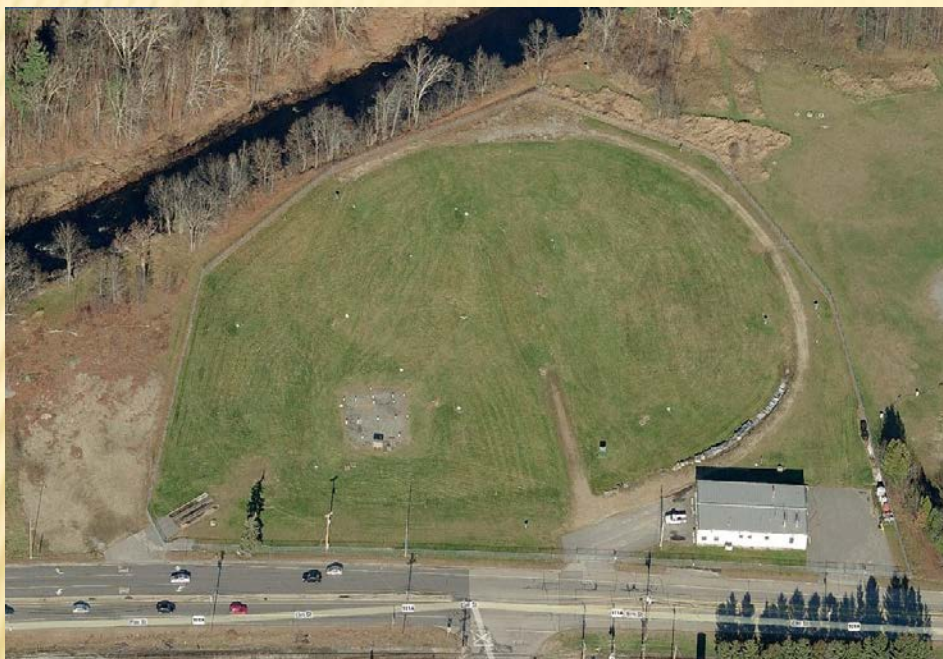
# SITE 3

- ✘ Objective: Containment more cost effective than P&T alone for DNAPL
  - ✘ Soil-bentonite slurry wall
  - ✘ Encloses 5-acres
  - ✘ 3-ft min wall thickness, 50 to 115 ft deep
  - ✘ No surface cap
- 
- Wall construction – 1998, P&T started – 1999
  - Two interior wells, pumping at 14 to 60 gpm
  - Discharge to exterior recharge gallery

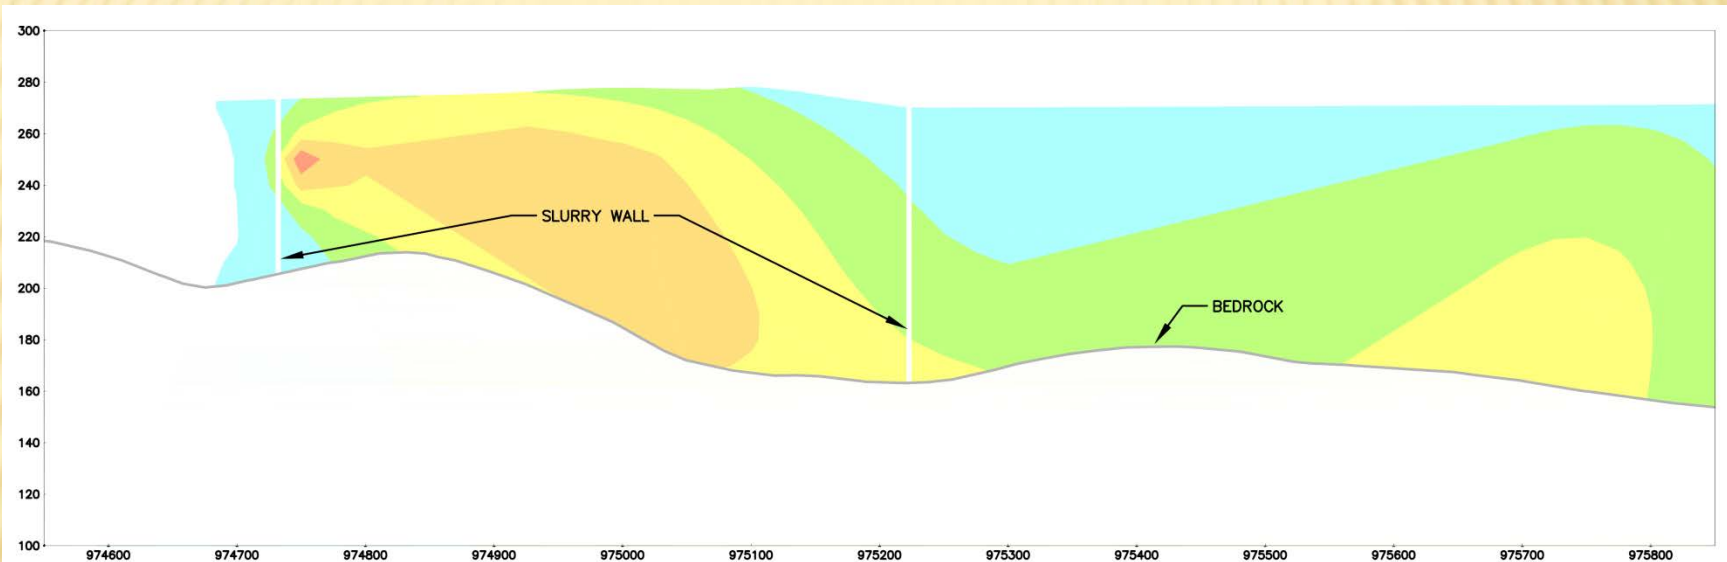
# SITE 3 – CROSS-SECTION AFTER WALL

Plume slightly exceeds MCLs in deep overburden outside wall in OU1 after 10 years.

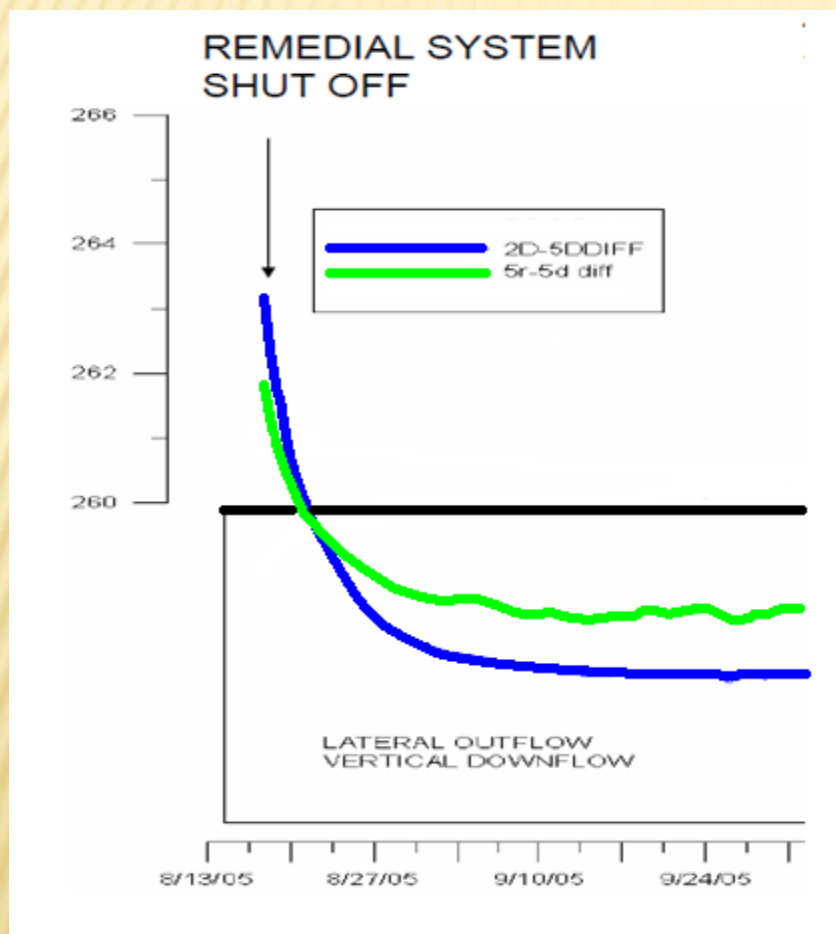
# SITE 3 - GRADIENTS

- ✘ Immediately after shutdown of extraction wells, groundwater gradients reverse
- ✘ With sufficient pumping rate, gradients are upward and inward
- ✘ Without pumping, gradients are downward and outward

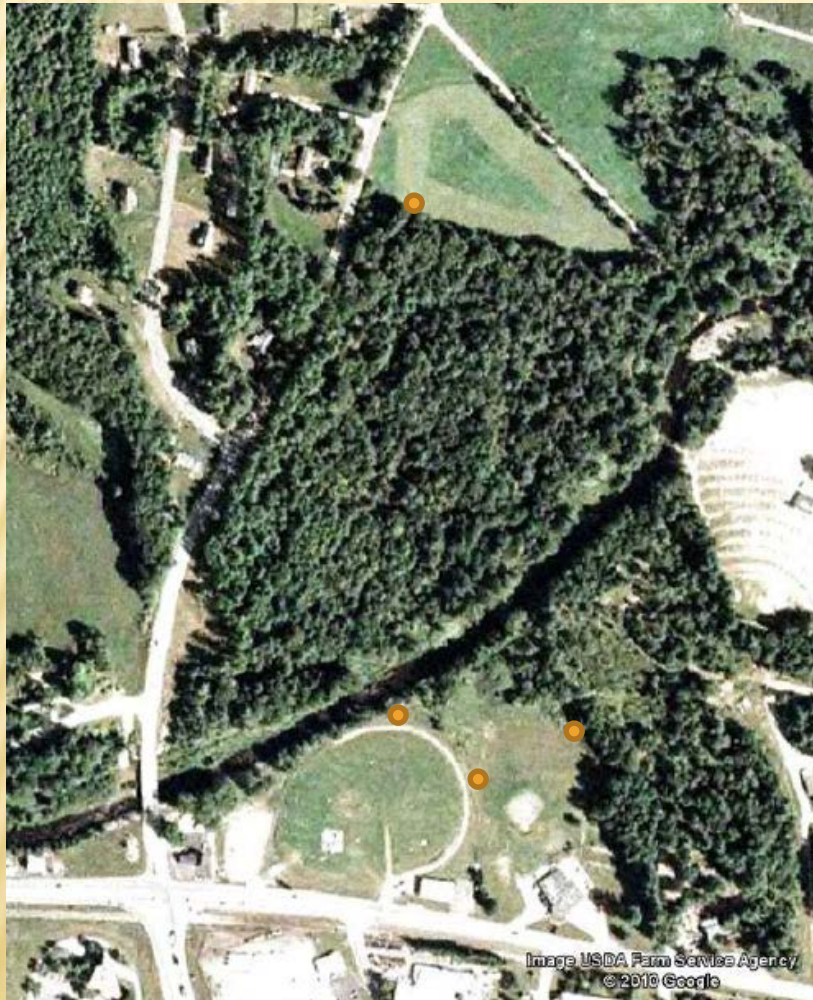
# SITE 3 - CURRENT STATUS

- ✘ 4 deep bedrock wells installed
- ✘ PCE as high as 8 ppm observed in deep bedrock beneath wall
- ✘ Further investigations in bedrock are planned
- ✘ Ongoing ISCO program in overburden inside wall

● Locations of new bedrock wells

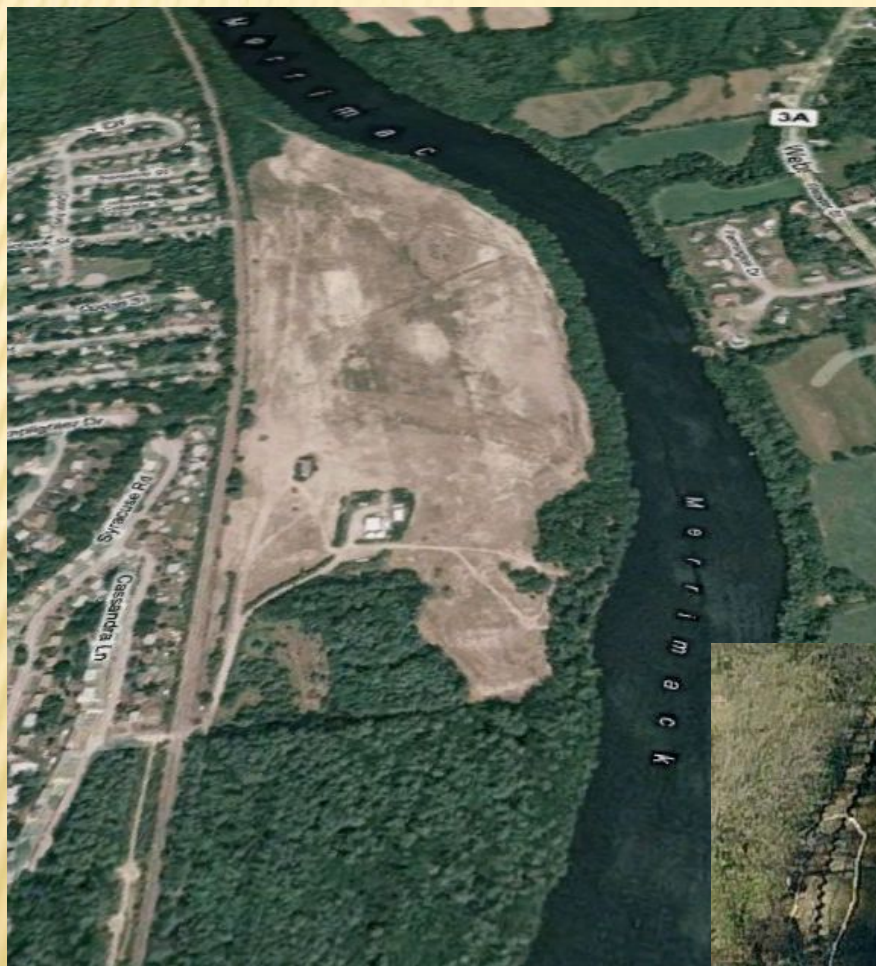
# SITE 4

- ✘ Creosote/fuel oil (NAPL)
- ✘ GW & NAPL extraction & treatment 1986 to 1997
- ✘ Sheet pile barrier system & product recovery wells constructed along 750 ft of river shoreline in 1997

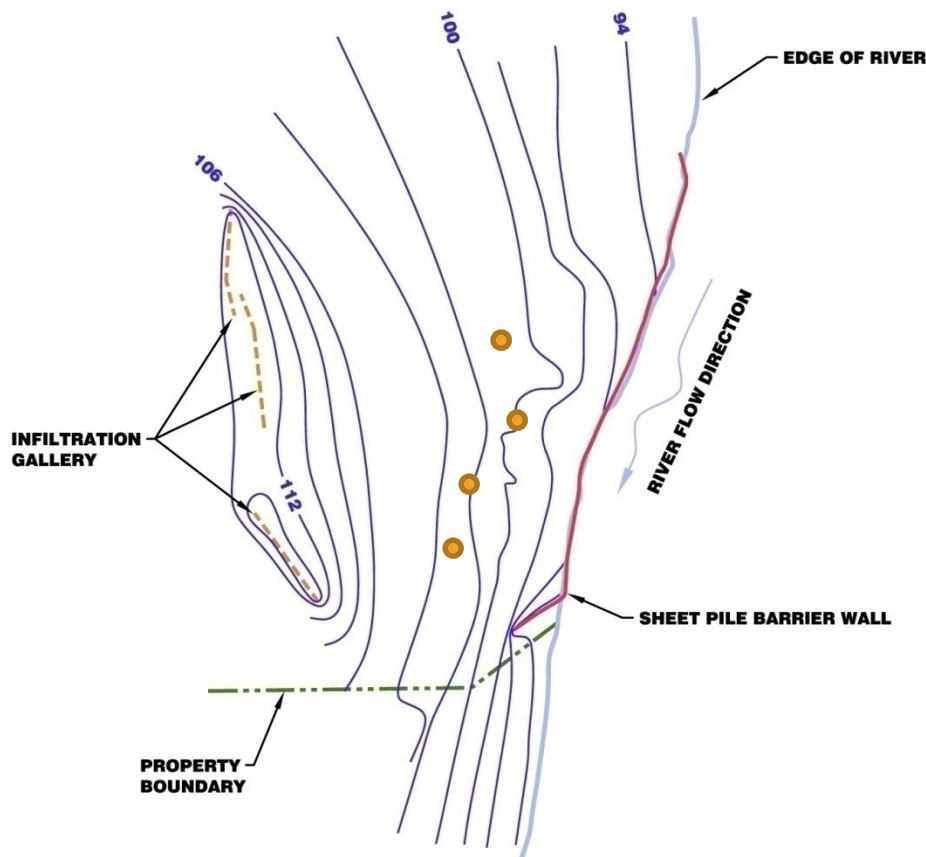
# SITE 4 - SITE PLAN

- ✘ 4 recovery wells
- ✘ 3 infiltration galleries, 500 ft long combined
- ✘ Original capacity was 30 gpm
- ✘ Current capacity is 20 gpm
- ✘ Pumping rates limited by infiltration gallery capacity

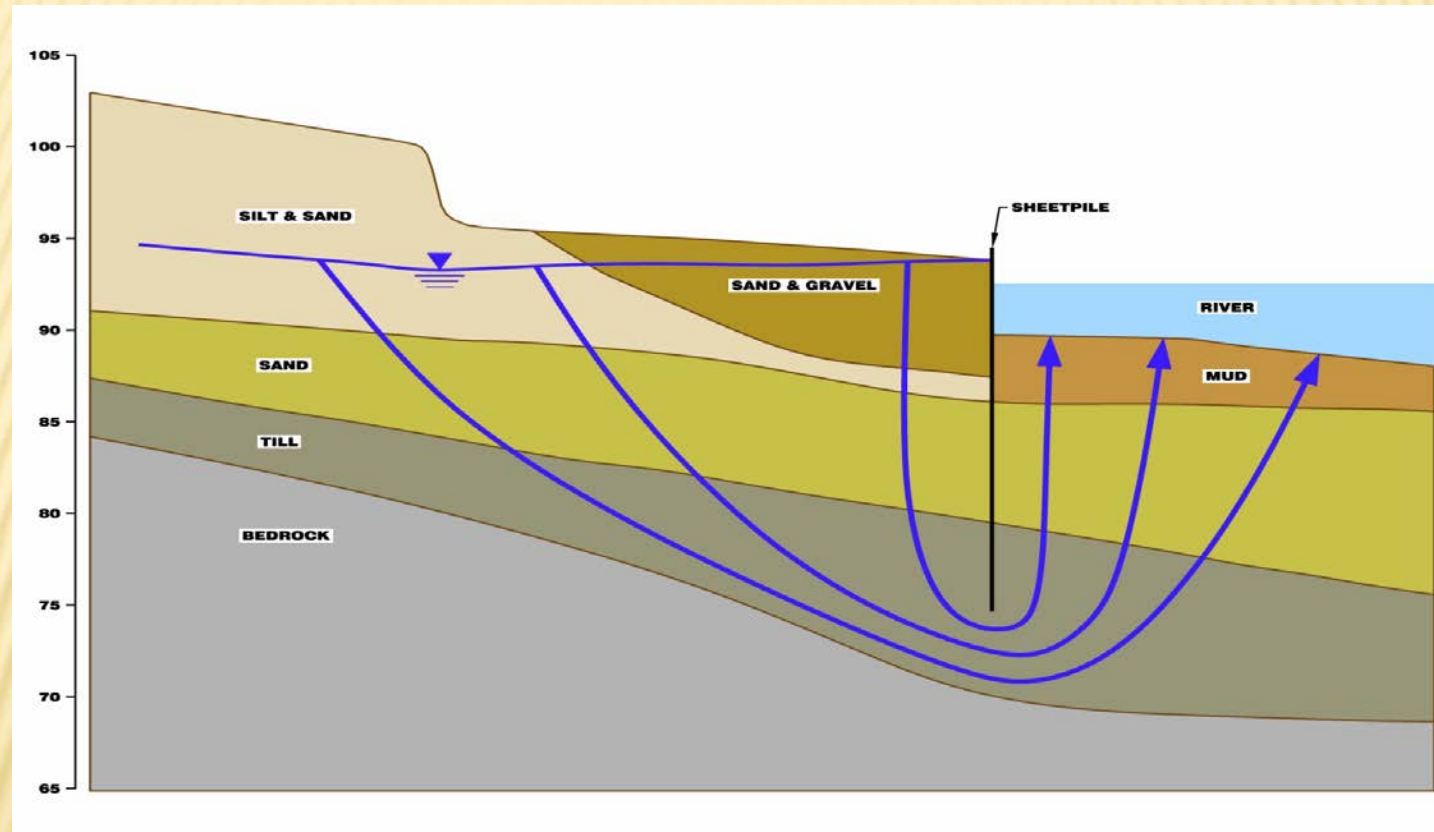
# SITE 4 - CROSS-SECTION

- Floating NAPL observed in river
- NAPL has been observed in till
- NAPL migrating through till beneath wall?

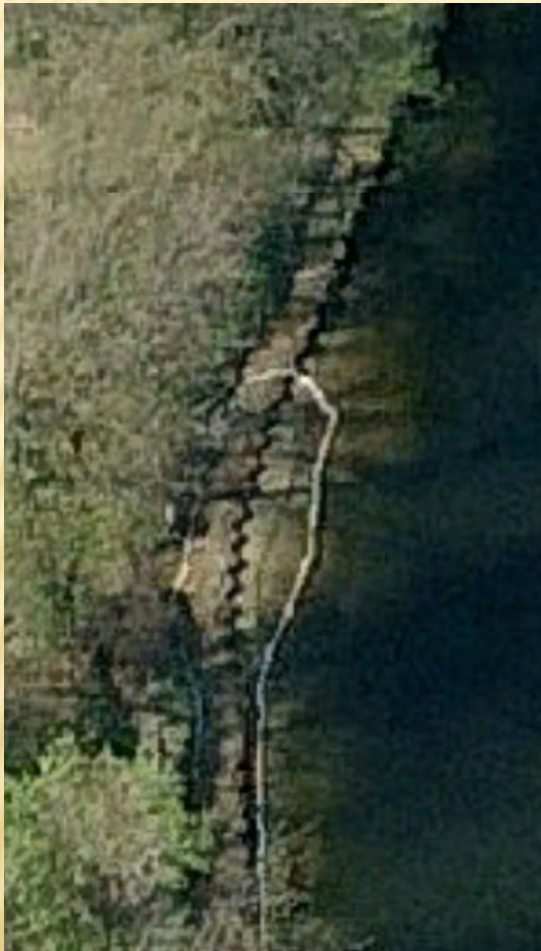
# SITE 4 – CURRENT STATUS

- ✘ Pumping rates limited by infiltration gallery capacity, resulting in periodic overtopping of wall
- ✘ Floating NAPL in river
- ✘ NAPL migrating through till beneath wall
- ✘ Infiltration galleries need expansion
