Deer Brook Gully Restoration, Georgia, Vermont

DEER BROOK is an 8.4 square-mile watershed located in Georgia and Fairfax, that flows south to Arrowhead Mountain Lake, which is part of the Lamoille River, and eventually drains to Lake Champlain. The brook is classified as sediment-impaired from its confluence with Arrowhead Mountain Lake to 2.5 miles upstream. The construction of I-89 and related U.S. Route 7 improvements in the 1970s, as well as the subsequent addition of homes and businesses near the intersection with Route 104A, have contributed to a substantial increase in stormwater runoff discharging to the head of the Deer Brook Gully. These stormwater flows, combined with deteriorating culverts along Route 7 and 104A in Georgia, have caused the gully to erode and deposit sediment into Deer Brook. The problem was first documented by ESPC and Stone in a 2007 report for the Northwest Regional Planning Commission (NRPC). Stone further evaluated the site and provided conceptual solutions to reduce flows to the Deer Brook Gully as part of a 2013 stormwater master planning project for the Friends of Northern Lake Champlain (FNLC) in Georgia, Vermont.

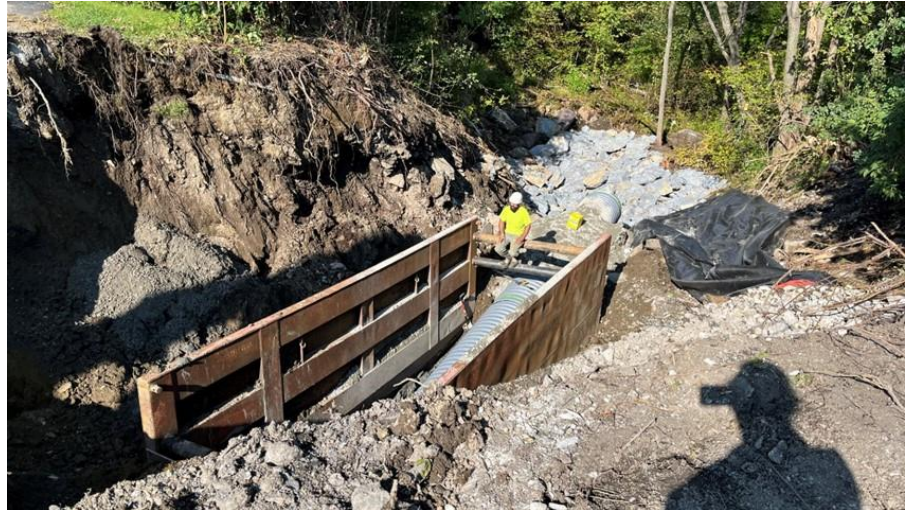
Installation of the new outfall and energy dissipating stone step pools on September 14, 2022.

The portion of the project constructed in September and October 2022 included gully and bank stabilization and installing a properly sized outlet, deep manhole, one deep sump catch basin, and all associated piping. Stone provided construction oversight throughout the duration of the project, including daily field reports and photo documentation. We are now supporting FNLC's application to the Missisquoi CWSP to construct the next phase of the project.

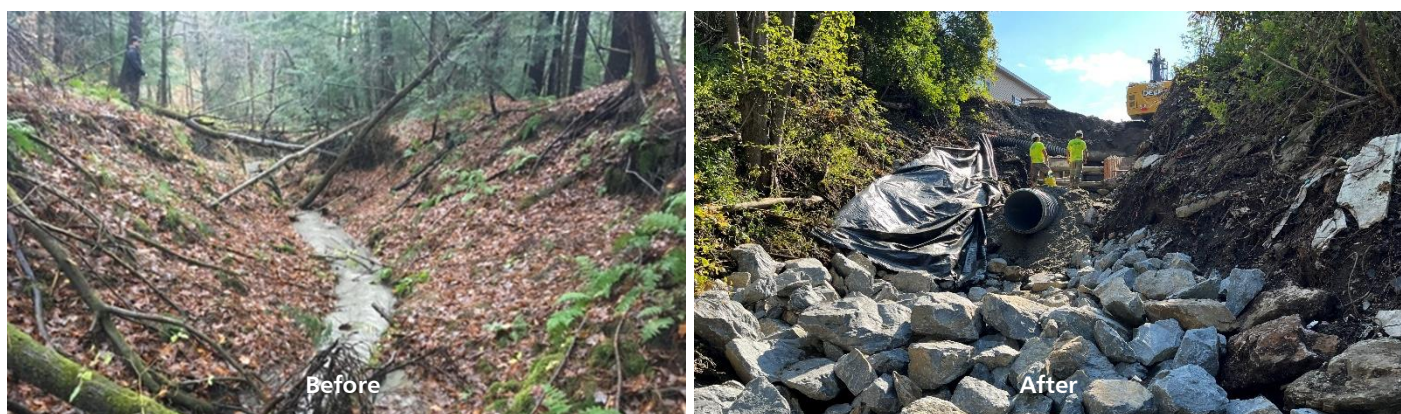
Left: Existing condition in the lower reach of Deer Brook gully, seen in November 2017. Gray-colored water in the channel is due to fine sediment transport during a moderate rain event. Right: Construction of new outfall and energy-dissipating stone step pools in September 2022.
