Pine Mill Dam Removal and River Channel Restoration in Haverhill, New Hampshire

STONE was retained by the Connecticut River Conservancy to provide engineering and design services for the removal of the Pine Mill Dam along Clark Brook in Haverhill, New Hampshire. The 15-foot-high by 180-foot-long concrete gravity dam was constructed c. 1928 to power an adjacent grist mill. The mill was in operation until electrical power replaced waterpower at the facility (c. 1941). Over time as the dam deteriorated, flows undermined its foundation. The dam impounded flows during spring runoff and large storm events at the conveyance, exacerbating flooding in the area. The increased flooding threatened the stability of the adjacent building, which was already in poor condition and connected to the dam through its foundation. It also added to substantial sediment accumulation behind the dam, altering structure and composition of the existing channel and its connection to adjacent floodplains. Despite flows bypassing the structure at times, the dam impeded the aquatic passage along Clark Brook. The goal of this project was to restore the river's ecological functions and critical habitat by improving

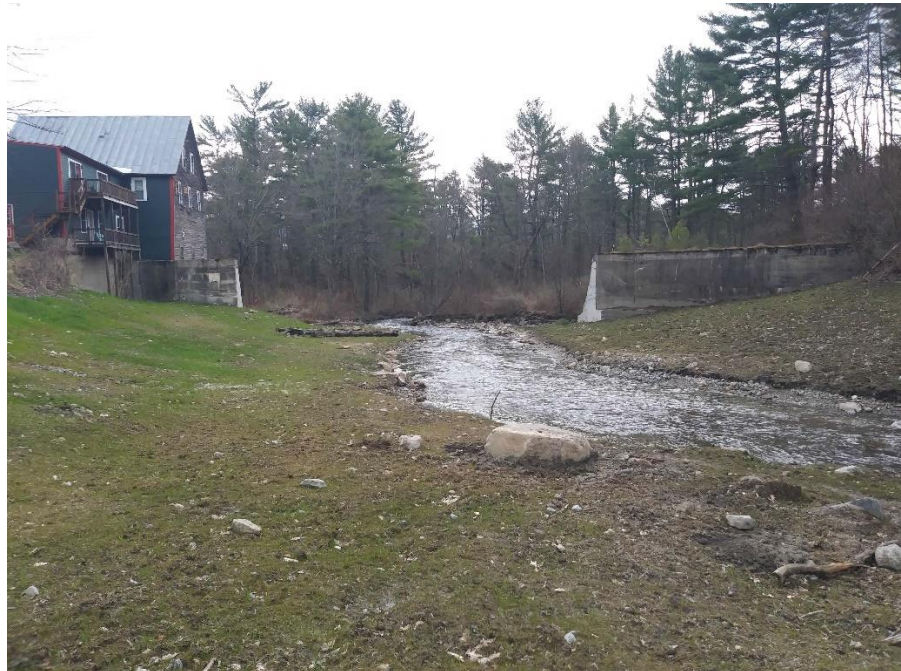
View of the project area, following the partial removal of the dam. The low-lying areas were seeded over with grass while the upland areas were planted with trees and shrubs.
