Cold Brook Dam Removal, Wilmington, Vermont

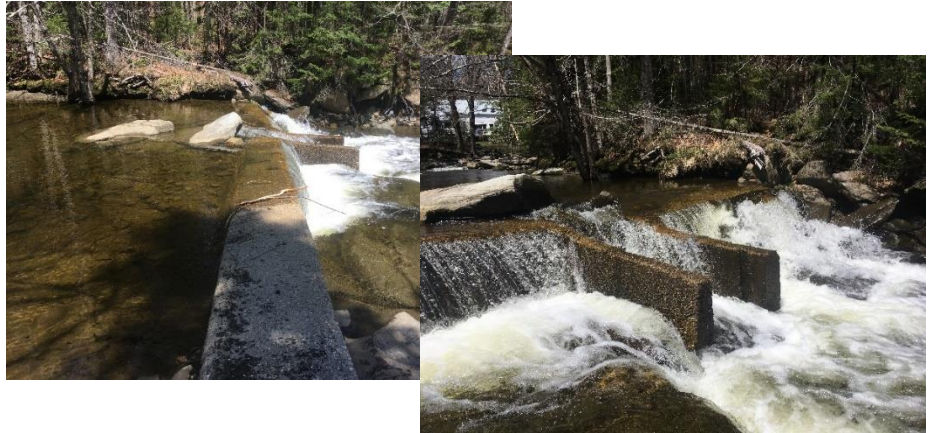
View along top of dam, looking northeast (left); View of dam and sluice, looking north (right). During a topographic survey in May 2017, Stone observed brook trout trying to unsuccessfully jump over the dam. (Source: Stone)
