Deer Brook Gully Restoration, Georgia, Vermont

STONE
ENVIRONMENTAL
100% EMPLOYEE-OWNED

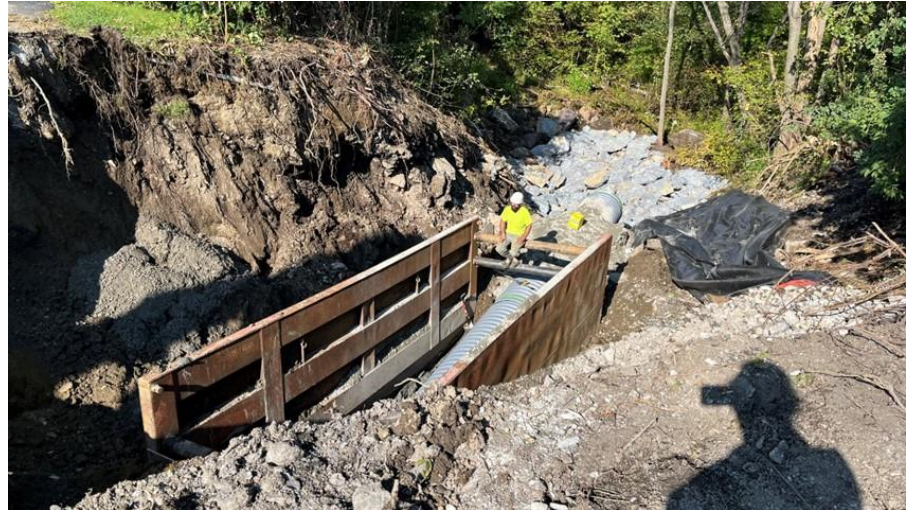
Installation of the new outfall and energy dissipating stone step pools in September 2022.

Following the submittal of 100 percent designs in mid-2019, Stone supported FNLC's efforts to secure funding to complete construction plans, permitting, and project implementation. In late 2020, FNLC and Stone received a Lake Champlain Basin Program grant administered by VT DEC, and the first phase of construction was completed in September and October 2022. Stone assisted FNLC through the bidding process by creating bid documents, advertising the project to prospective bidders, reviewing proposals, and selecting a contractor. Stone also provided construction oversight, including daily field reports and photos. The portion of the project constructed included gully and bank stabilization, installation of a properly sized outlet, a deep

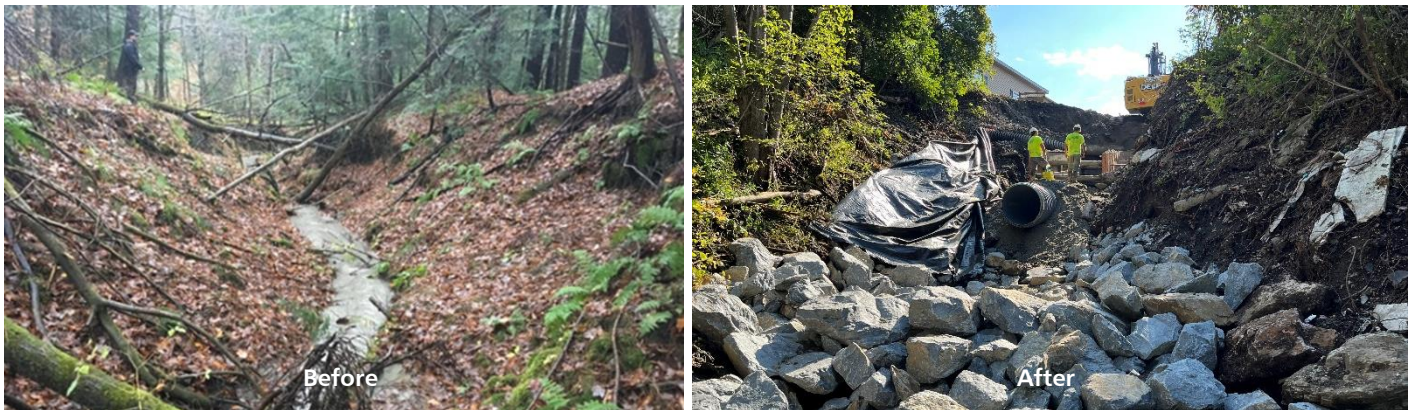
Left: The lower reach of the Deer Brook gully in November 2017. Gray water in the channel is due to fine sediment transport. Right: Construction of closed drainage system outlet improvements and energy-dissipating stone step pools in September 2022.

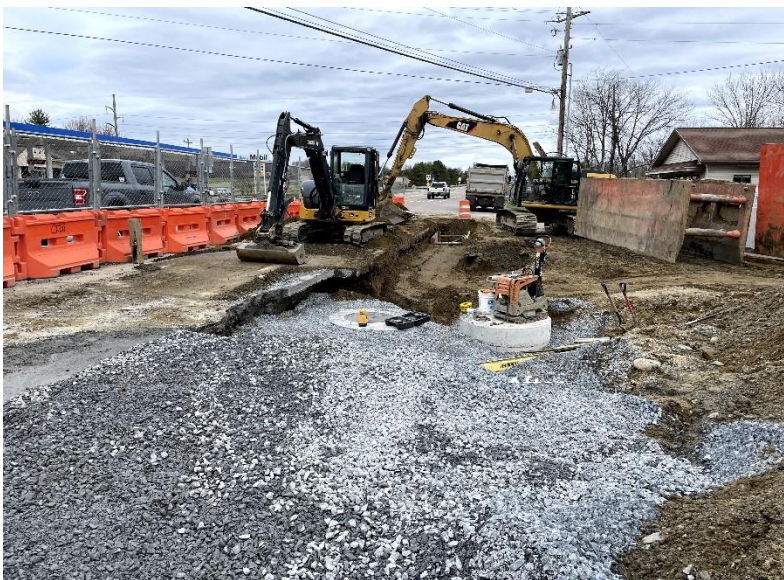
Installation of deep sump catch basin, drainage manhole, and associated stormwater culverts, April 2024

Stone then supported FNLC through the Watershed United Vermont (WUV) Block Grant application process that ultimately secured funding for the second phase of construction. FNLC chose to enter into an agreement with the contractor who constructed Phase I to also construct Phase II. Stone assisted with contracting and provided construction management, oversight, and reporting services throughout the duration of the second phase of construction. The work took place in spring of 2024 and was complete by early May.
