Johnsons Mill Dam Removal and Long-Term Monitoring

STONE
ENVIRONMENTAL
100% EMPLOYEE-OWNED

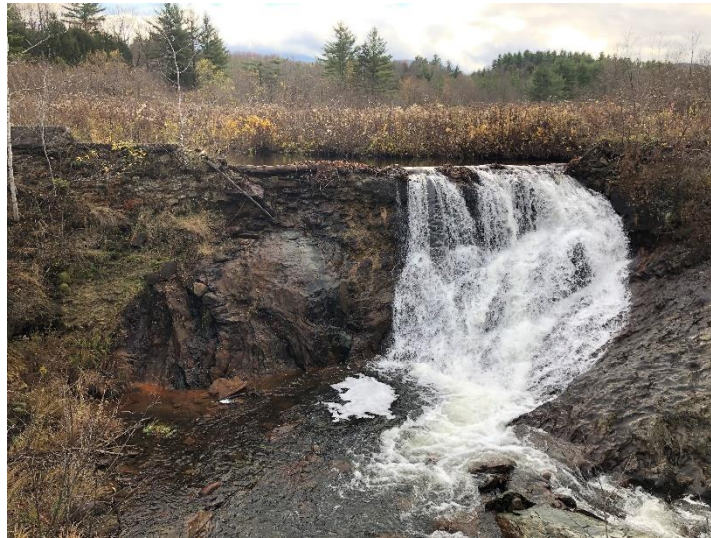
Looking upstream at the Johnsons Mill Dam along Bogue Branch in Bakersfield, Vermont in 2019.

IN 2019, the Franklin County Natural Resources Conservation District (FCNRCD) retained Stone to perform a dam removal feasibility assessment of Johnsons Mill Dam, located on the Bogue Branch in Bakersfield, Vermont. Once used to power a nearby sawmill, the obsolete dam caused adverse impacts on the habitat and migration of brook trout, a Species of Greatest Conservation Need in Vermont watersheds. Acting on behalf of a private landowner, the FCNRCD secured funding from the Vermont Department of Fish and Wildlife to remove the dam, restore the Bogue Branch to a free-flowing state, and improve water quality, flood resilience, and aquatic organism passage (AOP).

Stone completed surveying and sediment probing to determine if removing the dam structure would improve passage for brook trout and performed a geomorphic assessment of the reach upstream of the dam impoundment. These preliminary assessments indicated that AOP was likely following dam removal.

The Halloween storm in October 2019 brought over 4.5 inches of rain in less than 24 hours. Extreme floodwaters overtopped the dam and breached it at a vulnerable point. Following consultation with FCNRCD and assessment of the dam's condition, the design phase resumed with a resurvey of the site to account for adjustments following the storm. Survey data indicated downcutting of the former impoundment and upstream channel ranged from 0.5 to 4.5 feet from original grade, leaving near-vertical banks throughout the project area. Working with FCNRCD staff, Stone developed an adapted conceptual design for dam removal and bank stabilization, including estimating the volume of impounded sediment remaining. A one-dimensional hydraulic model was developed to simulate peak flows under existing conditions and proposed dam removal scenarios.

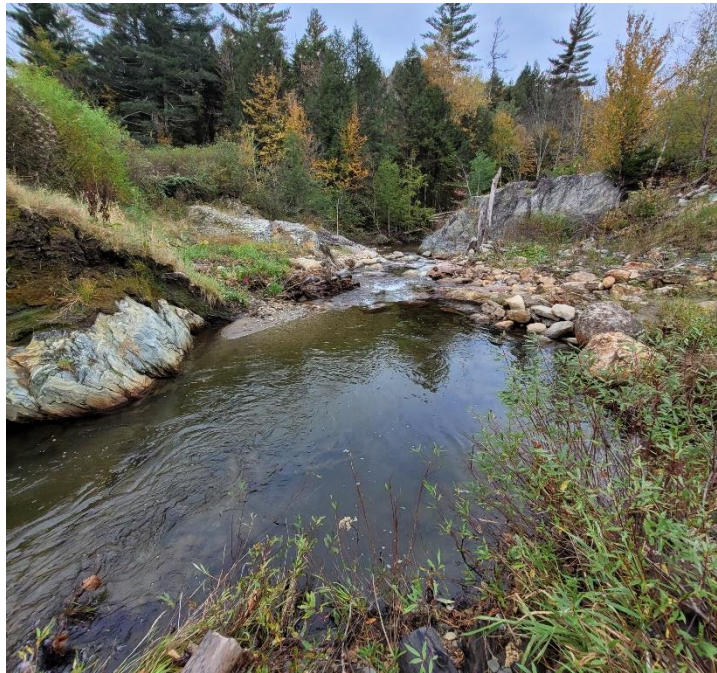
Looking downstream at the former Johnsons Mill Dam location along Bogue Branch in Bakersfield, Vermont in 2023.

Stone developed 100% engineering design plans and secured permits in 2020. Stone assisted with selecting a contractor and oversaw construction in 2021. Construction included dam removal, achievement of full AOP, and regrading of upstream banks to stable slopes, which were planted with native willows obtained onsite.

In spring 2022, FCNRCD retained Stone to perform long-term monitoring of channel adjustments and vegetation patterns over a four-year period. Starting in summer 2022 and during each monitoring year through 2025, Stone will collect longitudinal and cross-section survey data, bed material distribution via pebble counts, recruitment of large wood in the channel, and distribution, survival, and success of planted willows. Lateral bank adjustment and other details will be captured via seasonal drone aerial imagery (16 total flights), and sediment volume calculations will be performed using survey data. Plots of monitored longitudinal profile data versus design phase profiles will inform vertical adjustment patterns. This is one of the first dam removal long-term monitoring programs in the state.
