Johnsons Mill Dam Removal and Long-Term Monitoring

Bakersfield, Vermont

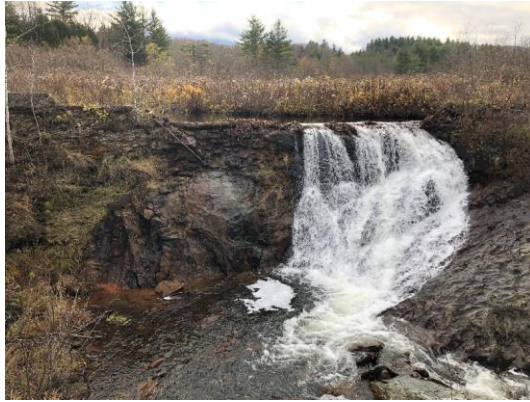
Looking upstream at the Johnsons Mill Dam along Bogue Branch in Bakersfield, Vermont in 2019.

The Halloween storm in October 2019 brought over 4.5 inches of rain in less than 24 hours. Extreme floodwaters overtopped the dam and breached it at a vulnerable point. Following consultation with FCNRCD and an assessment of the dam's condition, the design phase resumed with a resurvey of the site to account for adjustments following the storm. Survey data indicated downcutting of the former impoundment and upstream channel ranged from 0.5 to 4.5 feet from the original grade, leaving near-vertical banks throughout the project area. Working with FCNRCD staff, Stone developed an adapted conceptual design for dam removal and bank stabilization, including estimating the volume of impounded sediment remaining. A one-dimensional hydraulic model was developed to simulate peak flows under existing conditions and proposed dam removal scenarios.

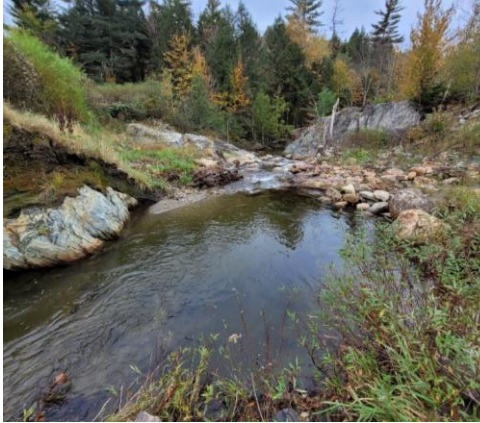
Looking downstream at the former Johnsons Mill Dam location along Bogue Branch in Bakersfield, Vermont in 2023.

Stone developed 100% engineering design plans and secured permits in 2020. Stone assisted with selecting a contractor and oversaw construction in 2021. Construction included dam removal, achievement of full AOP, and regrading of upstream banks to stable slopes, which were planted with native willows obtained onsite.
