Stevens River Bank Stabilization Barnet, Vermont

18-067

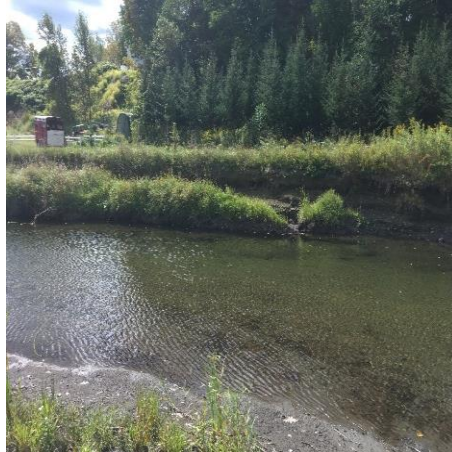
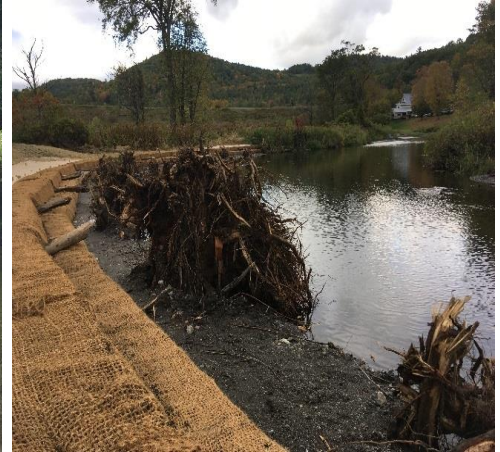
Eroding bank along meander bend of Stevens River adjacent to private property and horse farm (left); same meander bend following construction of bank stabilization measures (right).

STONE ENVIRONMENTAL was hired by the Connecticut River Conservancy to provide engineering design and construction management services for a bank stabilization project along a portion of the Stevens River in Barnet, Vermont. The project area included an incised meander bend that was migrating towards residential property, threatening to cut off access to a portion of the property used as horse pasture. Stone performed a geomorphic assessment to determine the source of the issue and concluded that the replacement of approximately 200 feet of stream channel with a concrete culvert had added excess energy in the system, accelerating the bend's migration.

The bank stabilization design plans included a large wood structure with over 50 pieces of wood and a toe reinforced with large stone. Channel and floodplain elevations were modified to mimic reference conditions, and the top of the wood structure was set at an elevation such that flood events beyond the 1.6 to 2-year recurrence interval will engage the floodplain. Erosion prevention measures, such as securing erosion control fabric and planting native shrubs, were completed in the newly graded floodplain. The large wood structure was designed to resist buoyancy, momentum, and drag forces associated with large flood events, as evaluated through hydraulic modeling.
