Pelletier Dam Removal and Engineering Design in Castleton, Vermont

STONE ENVIRONMENTAL was retained by the Vermont Natural Resources Council (VNRC) in 2018 to provide engineering and design services to remove the Pelletier Dam located along North Breton Brook in Castleton, Vermont. The Pelletier Dam was among several high-priority projects identified as part of the Vermont Dam Removal Initiative—a collaborative effort funded by the U.S. Fish and Wildlife Service and led by the VNRC and the Vermont Chapter of the Nature Conservancy (TNC)—to improve aquatic connectivity throughout the Lake Champlain watershed through the identification and removal of dams that no longer serve a useful purpose.

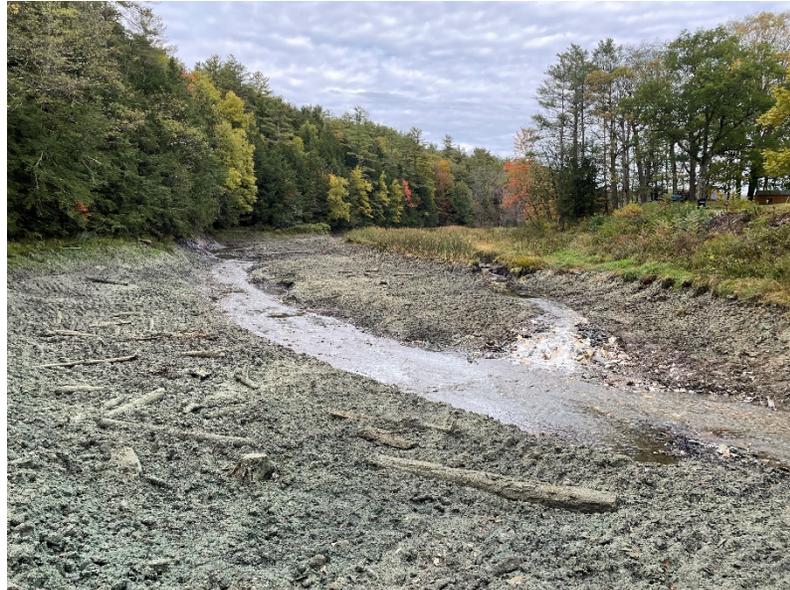
View from the former dam site upstream along the restored channel of North Breton Brook, Castleton, Vermont.

Stone's scientists and engineers completed a geomorphic assessment, created a sediment management plan, and developed a restoration design. Design plans included removing impounded sediment, regrading the pilot channel, and building floodplain benches to recreate vertical and lateral connection to adjacent floodplains.

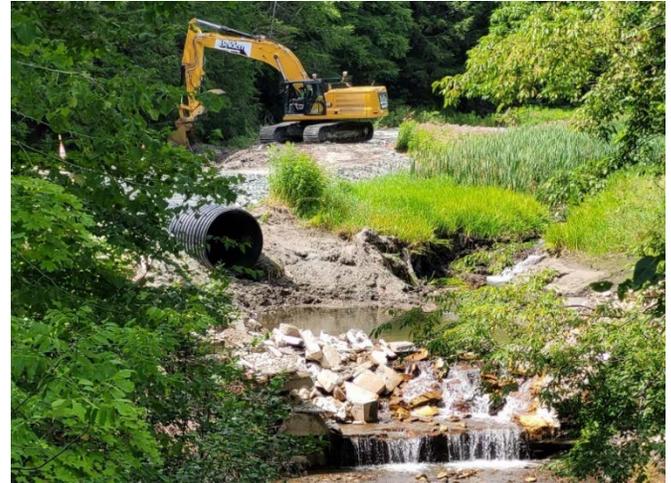
Breached face of the Pelletier Dam and impoundment (August, 2022)

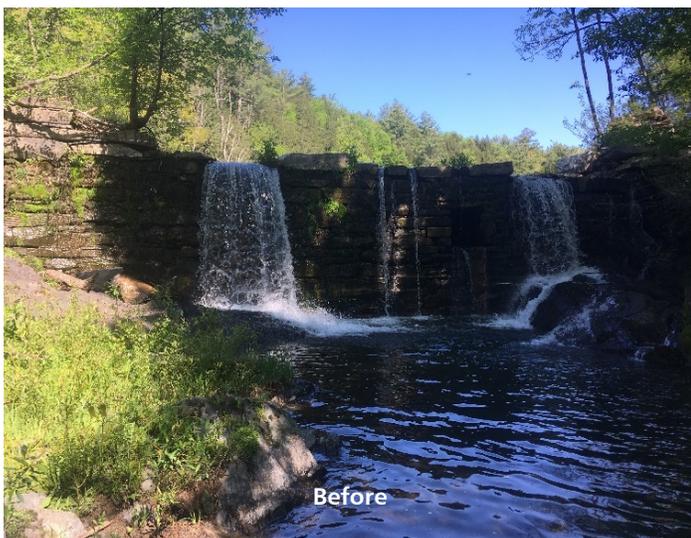
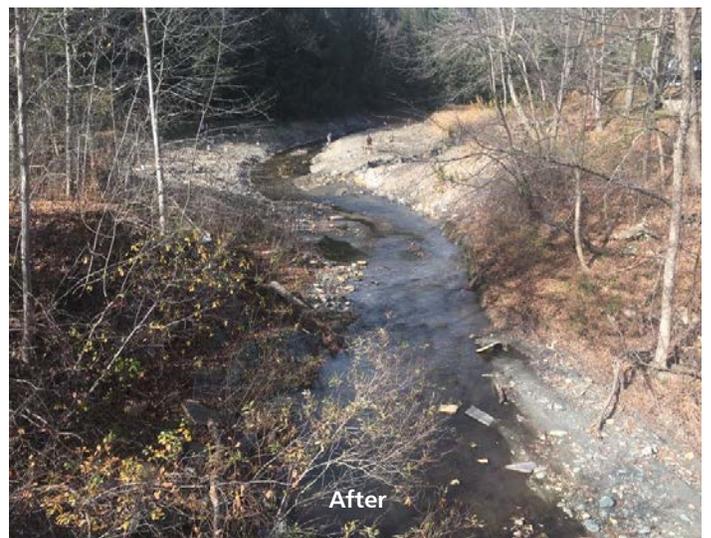
Downstream face of the Pelletier Dam (left) and North Breton Brook following dam removal (right) in October 2022.
