Seaver Brook Road-Stream Crossing Upgrade, Plaistow, New Hampshire

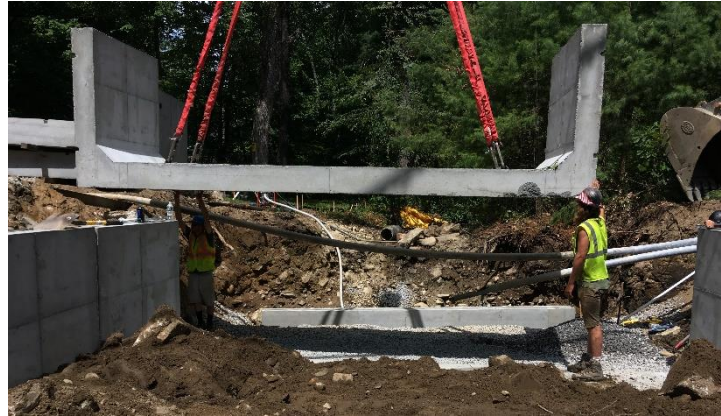
Concrete box culvert installation at Seaver Brook and Pollard Road, August 2020.

Stone conducted a geomorphic assessment which characterized the stream as Type E (Rosgen classification) with well-established floodplains. Stone's H&H work indicated that a significant increase in conveyance was required to mitigate flooding and meet design objectives, which included matching upstream and downstream water surface elevations during storm events and ensuring reasonable flow velocities downstream of the structure. Final design included a 18' wide by 5' high concrete box culvert, set at a slope that matched gradients in reference reaches upstream and downstream of the structure. Banks through the structure were included to accommodate terrestrial animal passage along this moderately busy residential road. Stone provided 100% design plans, an opinion of probable construction cost, bid documents and support, construction oversight and developed construction as-built plans. Construction was completed in summer of 2020.

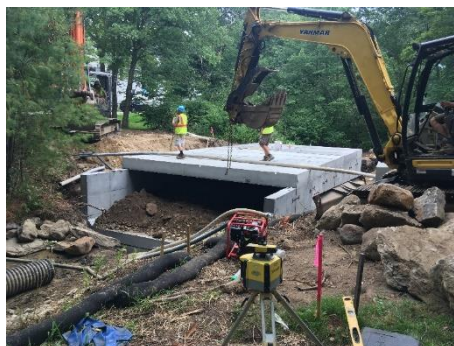
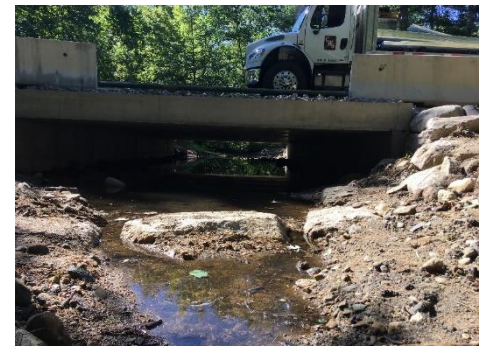
Left: Top sections of box culvert being installed following bottom section and channel bed material installation. Right: Completed channel restoration and box culvert installation, prior to final roadway improvements (paving, guardrail installation, etc.).
